PANMURE GATE  
Existing Condition

FIRHILL FOOTPATHS  
Existing Condition

FIRHILL FOOTPATHS Proposals

PANMURE BOARDWALK

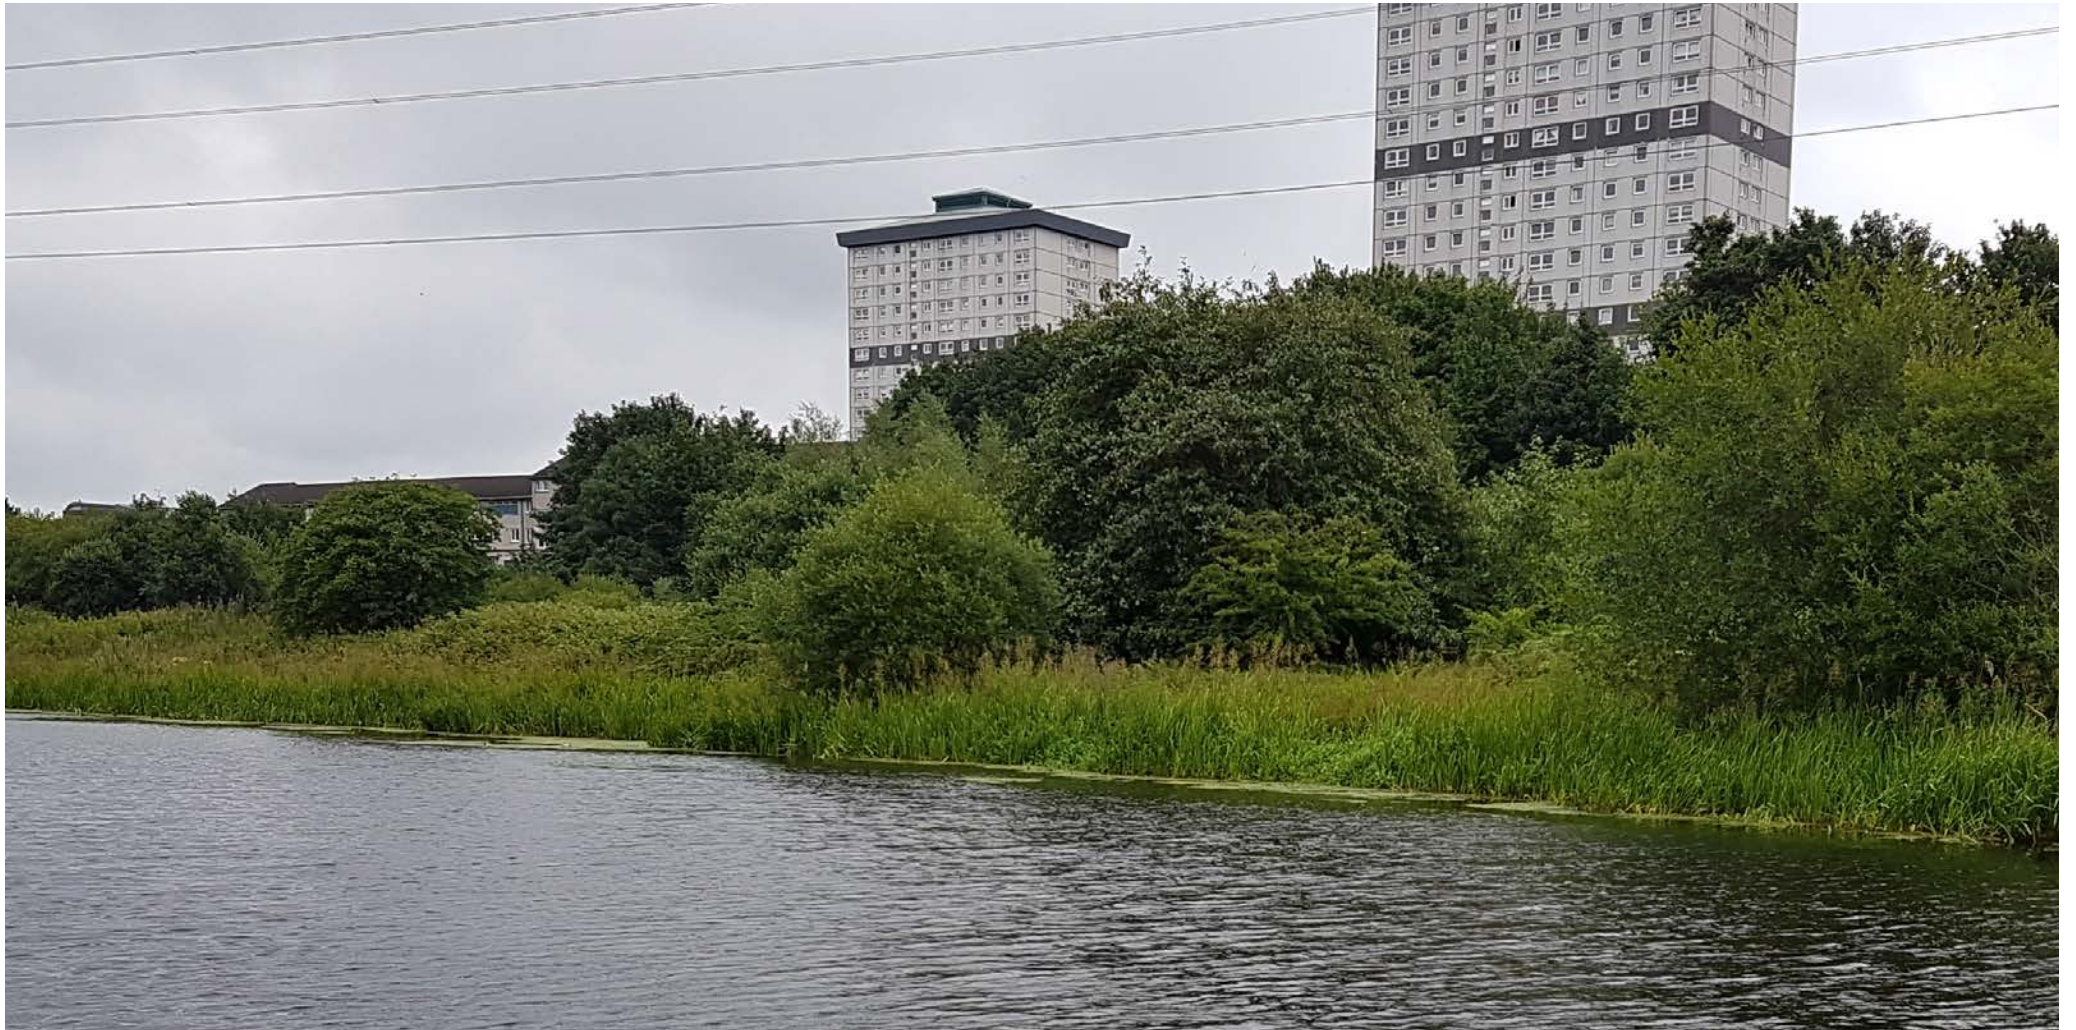
PANMURE BOARDWALK  
Existing Condition

Canal

Boardwalk

Claypits
